Good & Bad News from Space

OrbView-3 Launched; Landsat-7 Crippled

By Prof. Gordon Petrie

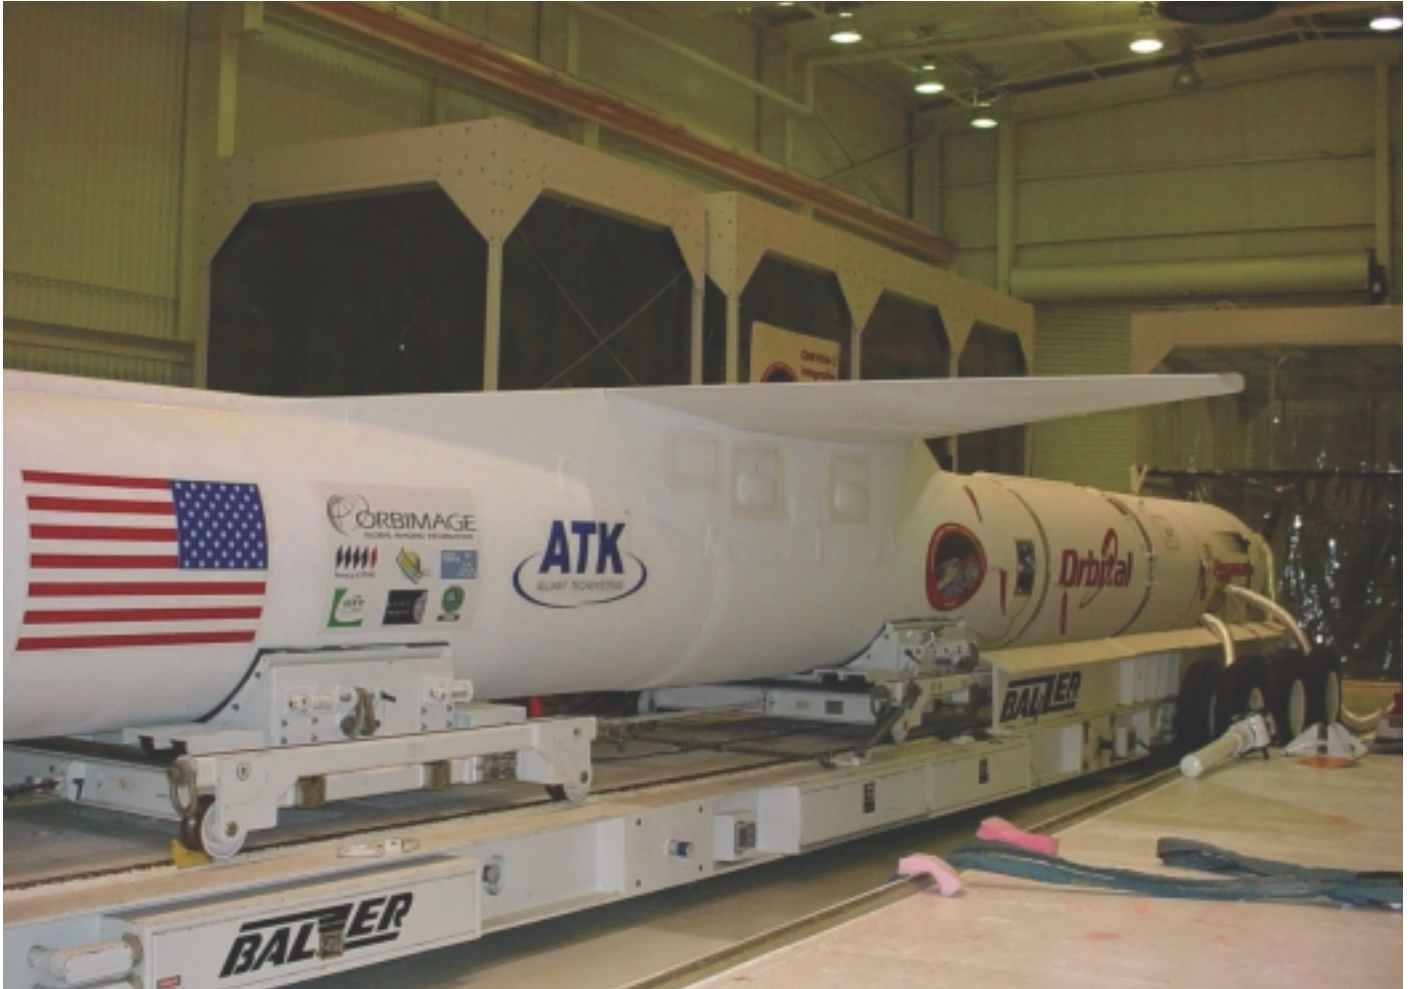
The air-launched Pegasus rocket with its tiny delta wing. The front part of the rocket houses the OrbView-3 satellite, which is covered by a protective fairing.

The OrbView-3 satellite was launched using the Pegasus air-launched rocket developed by the Orbital Sciences Corporation, which also built the satellite. This three-stage solid fuelled rocket was designed specifically to launch small satellites of up to 1,000 pounds (450kg) in weight into a low Earth orbit (LEO). In fact, the launch of OrbView-3 was the 34th flight of a Pegasus rocket, the first of which was flown in 1990. The rocket and the attached OrbView-3 satellite was mounted underneath a specially modified Lockheed L-1011 TriStar aircraft (called "Stargazer"). The aircraft then carried the Pegasus rocket and

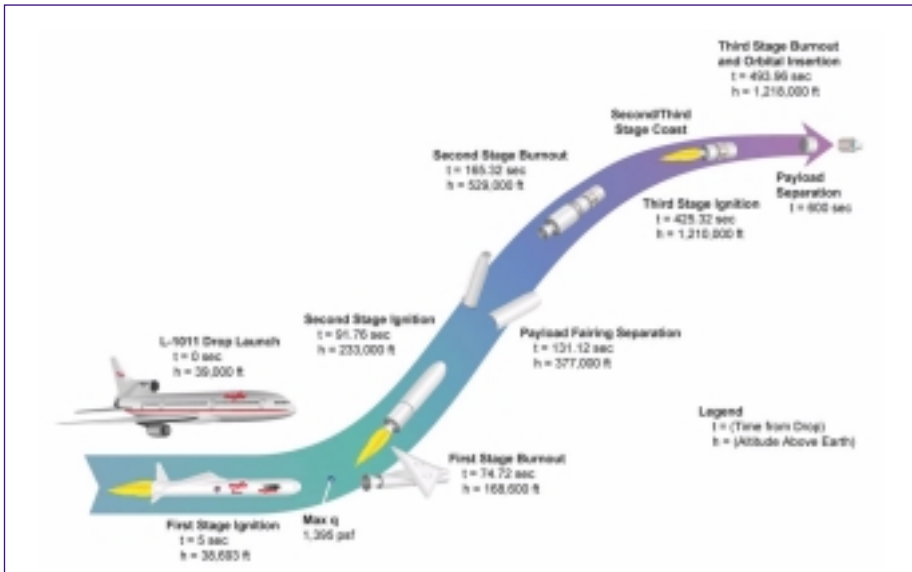
The mission profile for the launch of the Pegasus rocket, showing the three stages of the rocket propulsion; the ejection of the protective fairing; and the insertion of the satellite into its initial parking orbit. (Source: Orbital Sciences Corporation)

the satellite to an altitude of 40,000 ft. (12,192m) over the Pacific Ocean. Once the aircraft had reached the desired position, the rocket with its attached satellite was released and allowed to free-fall in a horizontal position for five seconds before starting its first-stage rocket motor. The launch went off successfully, placing OrbView-3 into its initial parking orbit. Over the next few weeks, the satellite will be manoeuvred into its final circular Sun-synchronous orbit having an orbital inclination of 97.29° and an orbital altitude of 470km. Besides these orbital manoeuvres, the satellite and its imager will need to be checked out fully before it can be declared to be operational.
